SR 15 SECTION 088 CSVT SOUTHERN SECTION

PUBLIC MEETING FEBRUARY 15, 2017

REVIEW OF CSVT SOUTHERN SECTION

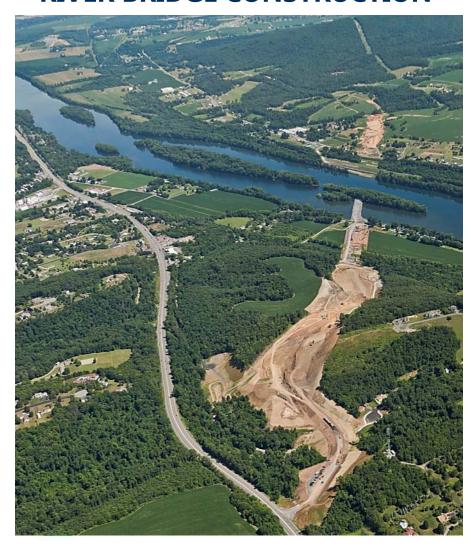
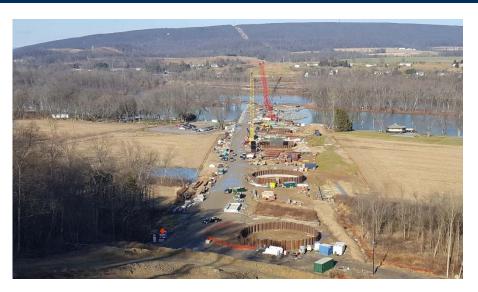
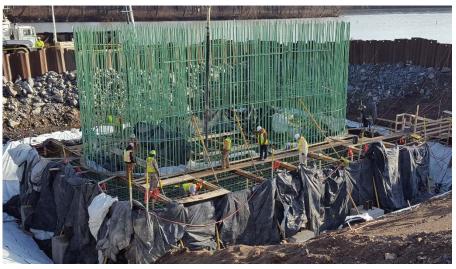
RIVER BRIDGE CONSTRUCTION

- ➤ 1st Contract River Bridge
 - Awarded October 2015 Trumbull Corporation \$156 million
 - Work began January 2016 30% complete
- > 2nd Contract Earthwork/Structures north of river
 - Awarded October 2016 Trumbull Corporation \$61 million
 - Work began November 2016
- > 3rd Contract Earthwork/Structures south of river (US 15 Interchange)
 - Anticipated bid opening March 2017
- ➤ 4th Contract Paving
 - Anticipated bid opening 2020
- Overall anticipated completion 2021

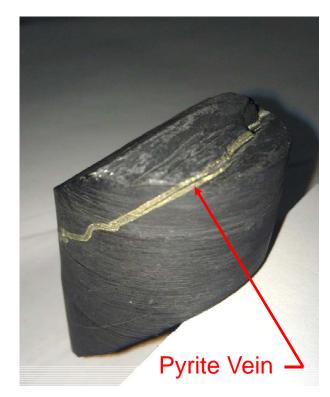
Pyrite Sample

- Rock containing iron sulfide such as pyrite.
- Produces acid at a quick rate when...
 - excavated into smaller pieces
 - smaller pieces exposed to air and water
- ➤ Why important?
 - If untreated, may result in issues similar to acid mine drainage

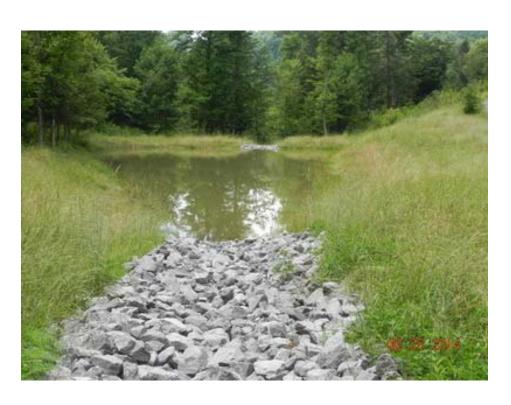
HOW DO WE ADDRESS POTENTIALLY ACIDIC ROCK?

- Awareness is key
- Coordinate with PADEP
- Minimize amount of acid bearing rock to be excavated
- Divert & treat stormwater runoff from exposed rock slopes
- Mix excavated rock with lime and encapsulate (to prevent contact with air and water)

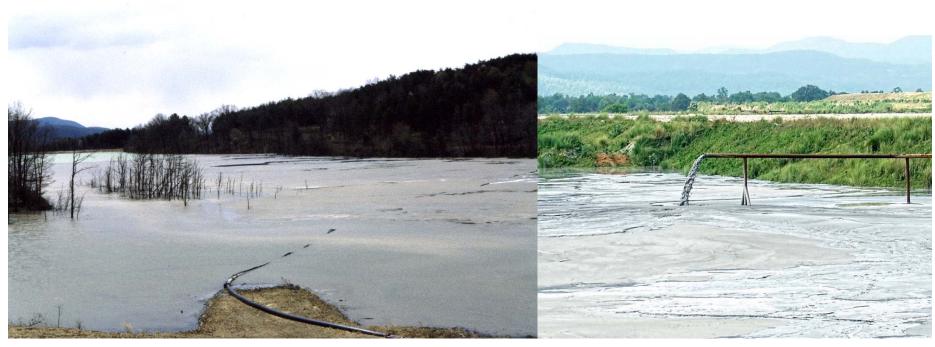
ASH BASINS

Northern Basin in use

Example of ash being pumped into a basin

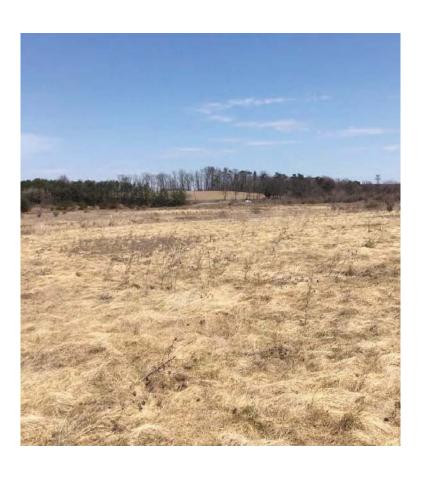
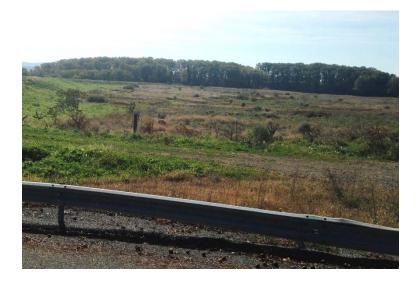
SOUTHERN ASH BASIN

- ➤ Built in 1955
- Raised crest in 1964, and between 1984-1986
- > Closed in the late 1990s
- ➤ Dam Height 136′
- ➤ Area 66 Acres

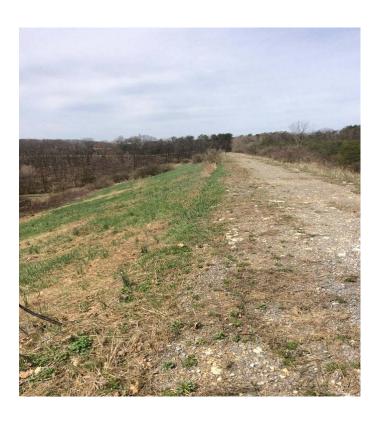
NORTHERN ASH BASIN

- ➤ Built in 1970
- > Raised crest 1981-1982
- > Closed in the late 1980s
- ➤ Dam Height 117′
- > Area 61 Acres

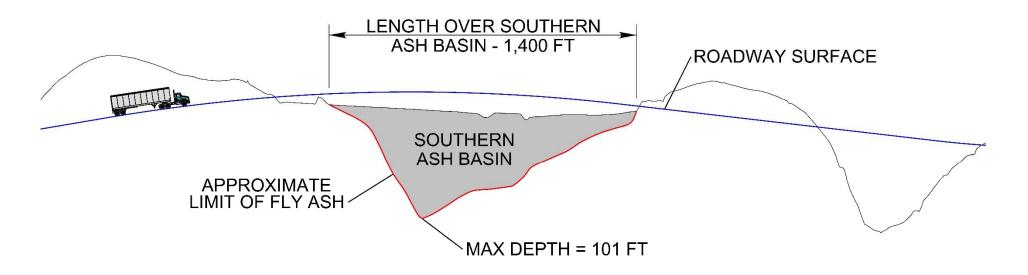
CSVT PROFILE THROUGH SOUTHERN ASH BASIN

Note: Drawing is not to scale.

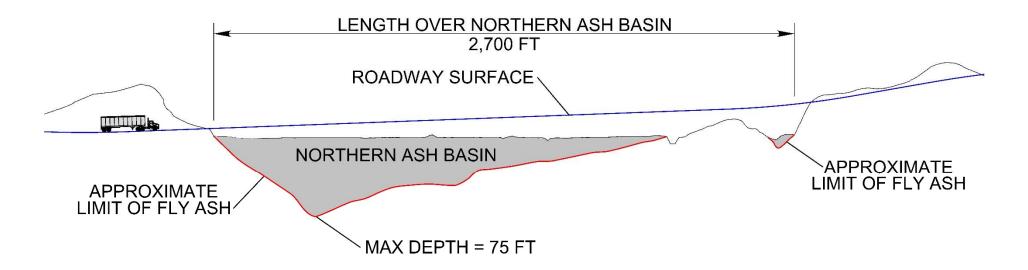
CSVT PROFILE THROUGH NORTHERN ASH BASIN

Note: Drawing is not to scale.

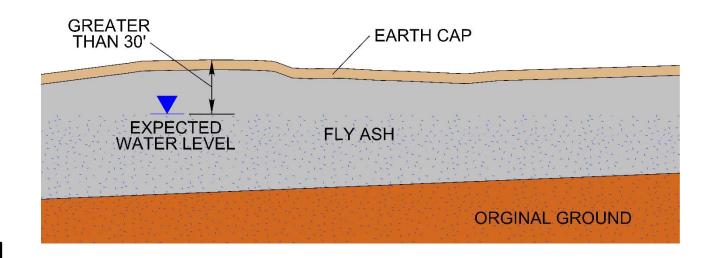
EXPECTED CONDITIONS

- ➤ Water level > 30 feet below surface
- Increasing ash strength with depth
- > Stable for highway construction

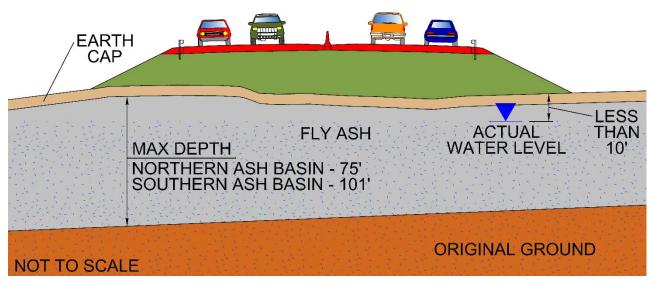
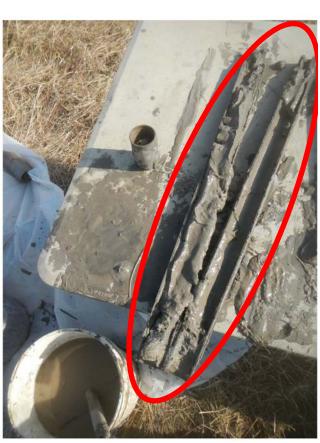
ACTUAL CONDITIONS

- Saturated ash within 10 feet of surface
- Consistency similar to toothpaste or a milkshake
- Very little strength
- > Little gain in strength over depth

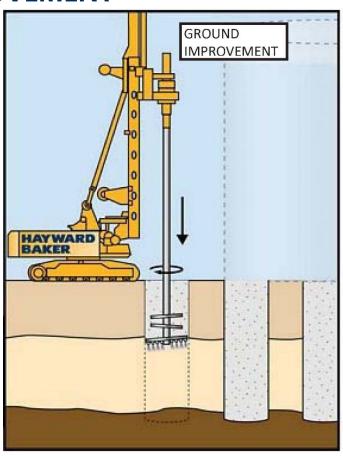
CONSIDERED SOLUTION – GROUND IMPROVEMENT

- Inject cement slurry into ash basin to make columns which support highway
- > Issues
 - Risk of highway embankment settlement
 - Risk of groundwater contamination
 - Cannot verify condition of mixed columns under 100 feet of ash
 - PennDOT (public) liability for ash basins and dams
 - Additional \$70 million
 - Time delay

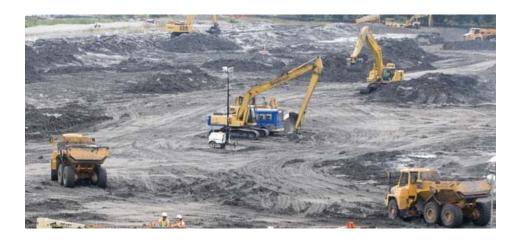
CONSIDERED SOLUTION – REMOVAL OF ASH FROM BASINS

- > Remove all 7.5 million cubic yards of ash
- > Issues
 - Risks spreading contaminants during excavation and transport
 - Cost prohibitive; well over an additional \$500 million
 - Would set CSVT schedule back several years

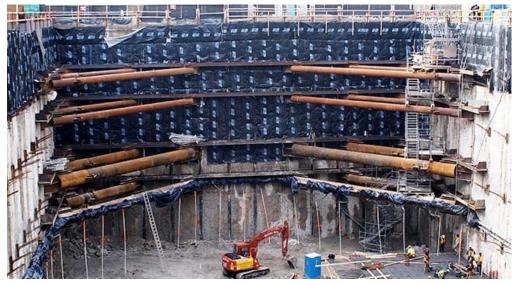
CONSIDERED SOLUTION – REMOVAL OF ASH UNDER CSVT

- Excavate ash beneath CSVT (2 million cubic yards)
- > Issues
 - Same challenges as previous approach plus....
 - Large bracing systems needed (100' height!)
 - Need to pass water from one side of the bracing system to the other
 - Over an additional \$250 million

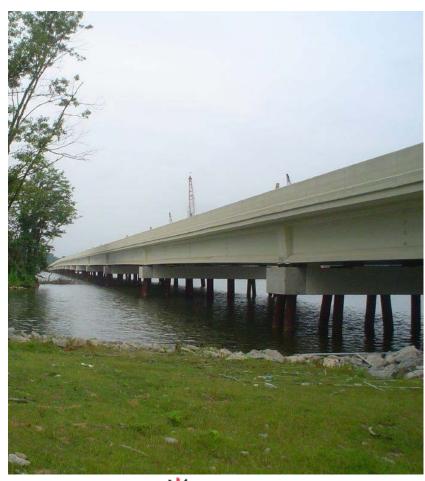
CONSIDERED SOLUTION – BRIDGING BASIN

- Construct low bridge over ash basins
- > Issues
 - Ash basin cannot withstand large cranes necessary for bridge construction.
 - Pile driving could fracture rock below risking contamination of aquifer.
 - Additional \$160 million initial cost plus ground improvement

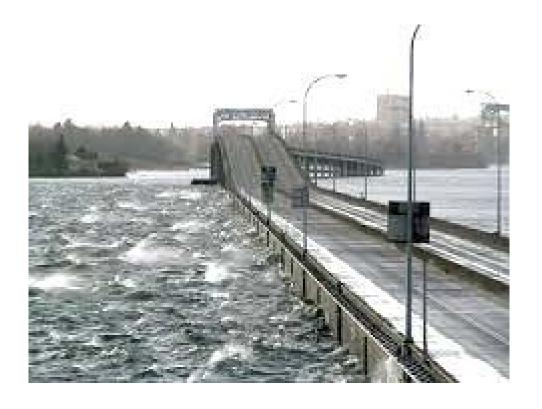
CONSIDERED SOLUTION – FLOATING BRIDGE

- "Out-of-the-box idea"
- Construct pontoons that "float" on ash
- > Issues
 - Pontoons would gradually settle with no way to raise them.
 - Risk of failure during seismic event
 - Additional \$450 million
